TYRONE POWER COMPANY DAM

SCHUYLER COUNTY, NEW YORK

INVENTORY NO. N.Y. 454

PHASE I INSPECTION REPORT
NATIONAL DAM SAFETY PROGRAM
TYRONE POWER COMPANY DAM
N.Y. 454
DEC I.D. NO. 54-1596
CHEMUNG RIVER BASIN
SCHUYLER COUNTY, NEW YORK

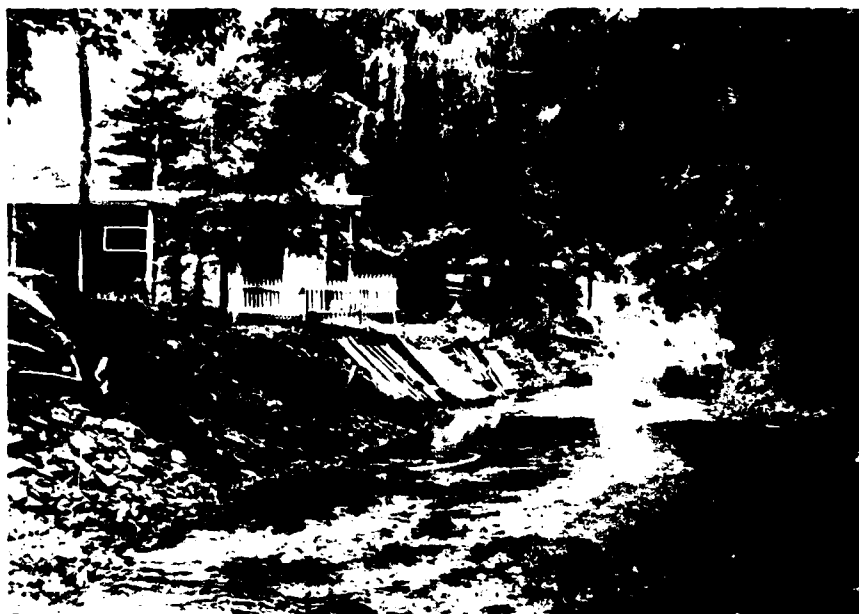
The dam is classified to be in the high hazard category. A campground is located approximately one mile downstream from the dam which includes about 5 to 10 camp trailers situated adjacent to Tobehanna Creek. The floor levels of the trailers are in the range of four to six feet from the adjacent stream bed. In addition, two houses which are estimated to be within eight to ten feet in elevation from the adjacent stream bed are also considered to be within the potential floodplain of Tobehanna Creek in the event of a dam failure. Based on visual observations, it is estimated that failure of the dam would cause loss of more than a few lives and appreciable property damage in the campground area.

PHOTOGRAPH NO. 6
Campgrounds (approximately 0.5 mile downstream)
